# **Sydney Metro West**

## **Parramatta Station Construction Site**

### **Enabling Works**

**Preliminary Results Report**

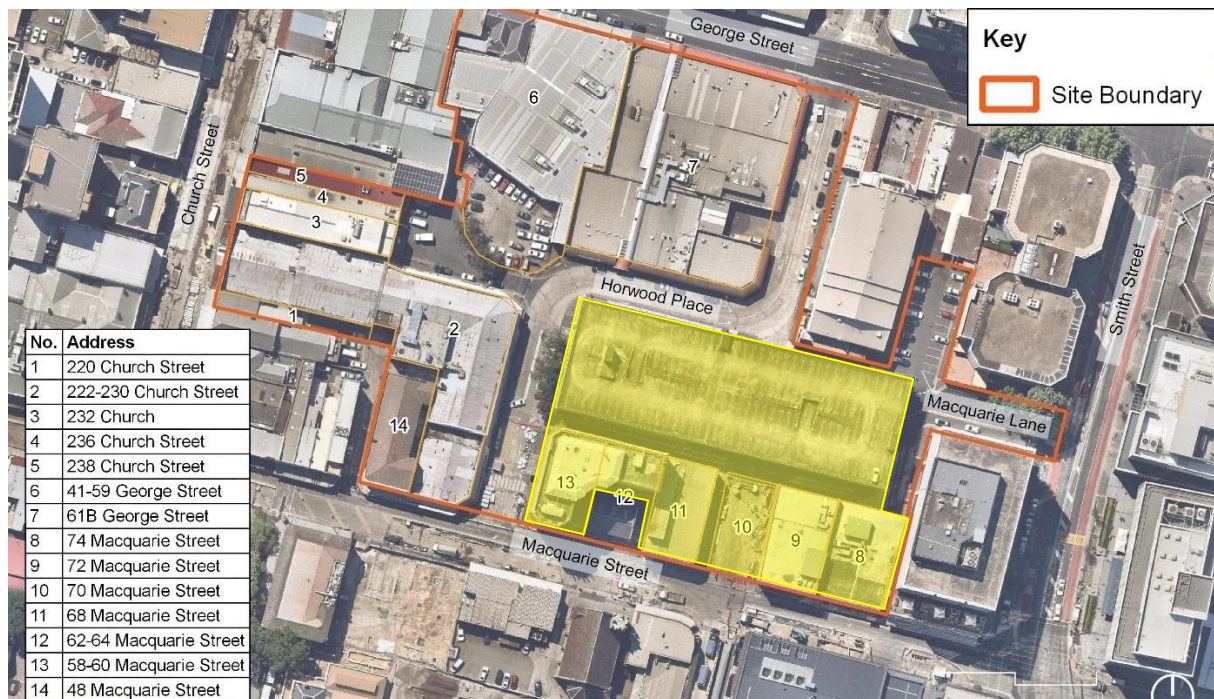
Figure 1.2 The enabling works archaeological excavation area (yellow shading) within the southwest portion of the site. (Source: Nearmap with GML overlay)

The Parramatta station construction site is in the Parramatta CBD and is bounded by George, Smith, Macquarie and Church streets (Figure 1.1). The archaeological excavation for the enabling works was in the southwest portion of the site—referred to as 'the site' throughout this report (Figure 1.2). The site comprised the former Nos 58–60, 62–64, 68, 70, 72 and 74 Macquarie Street, the Horwood Place multilevel carpark and a portion of Macquarie Lane.

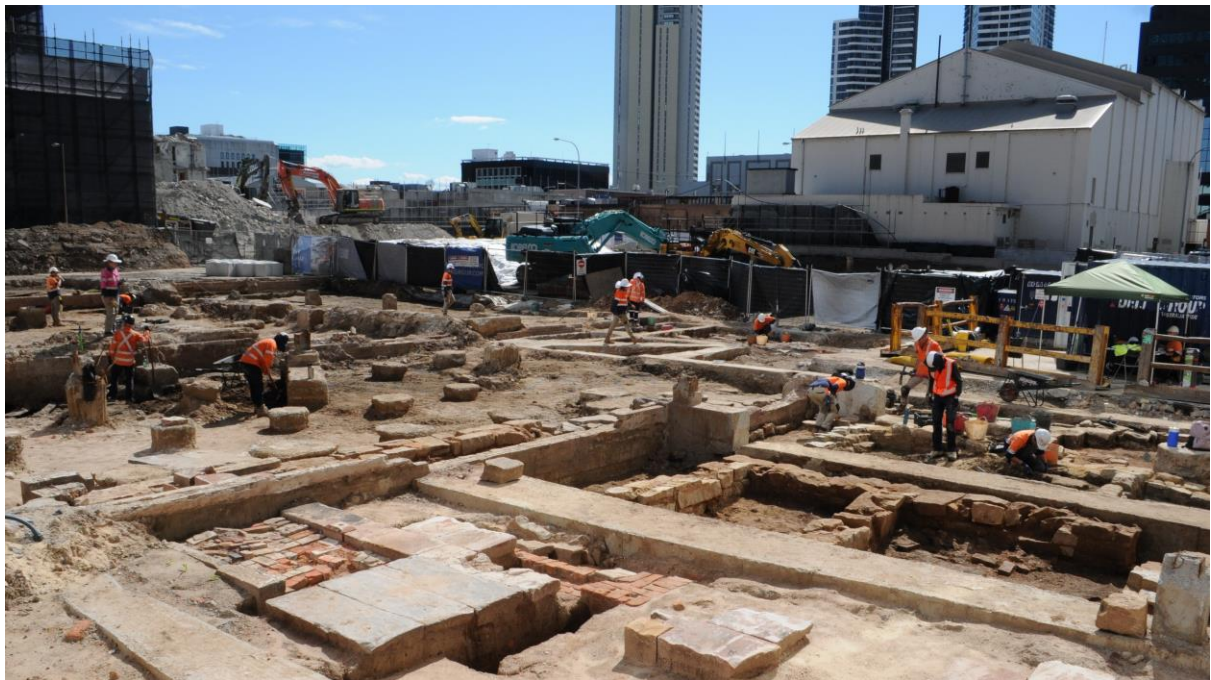
Figure 1.3 Archaeological excavation in progress in Area A along the Macquarie Street frontage. In the background, demolition continues in Area B. Photograph taken looking northwest.

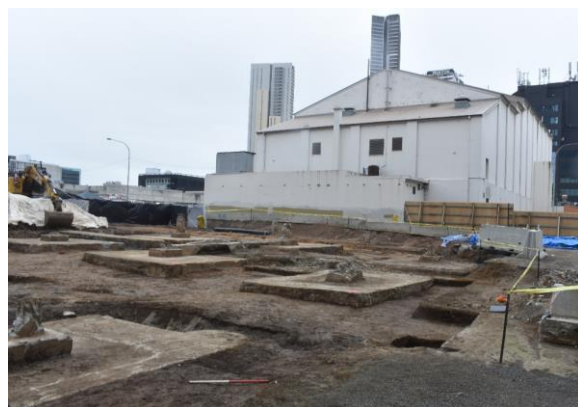
Figure 1.4 Archaeological excavation under way behind the Roxy within Area B and the station box excavation footprint. This area contained large pad footings from the multilevel carpark. Photograph taken looking north.

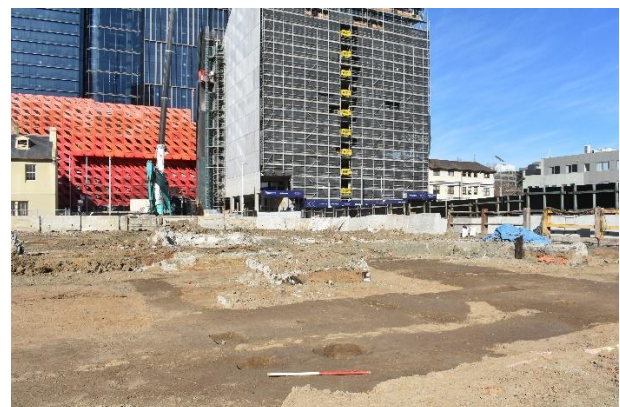
Figure 1.5 The western part of Area B showing localised areas of archaeology between major impacts from the multilevel carpark. Photograph taken looking south towards Macquarie Street. Scale is 1m.

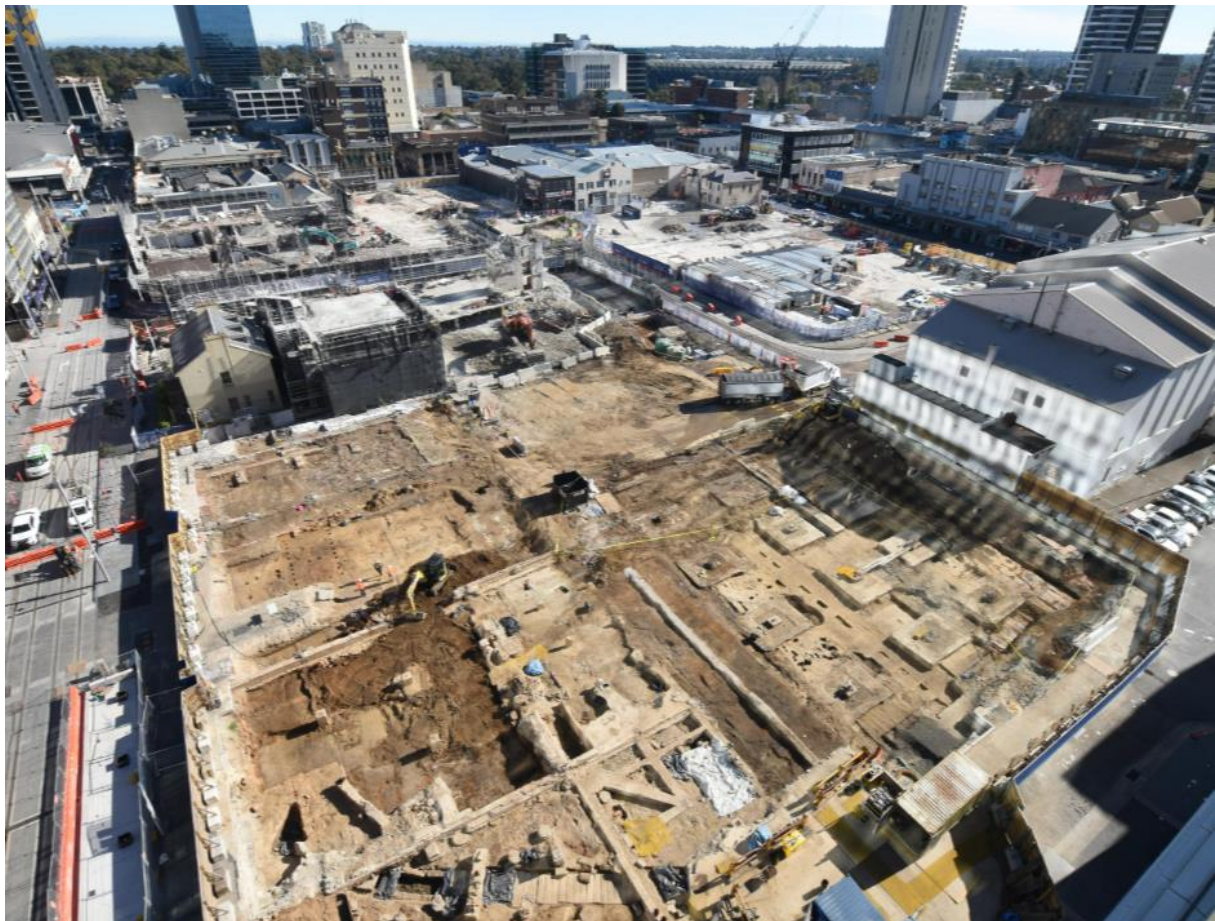
Figure 1.6 View of the enabling works archaeological excavation from the site time-lapse camera in June 2022. Photograph taken looking northwest. (Source: Delta site camera, June 2022)

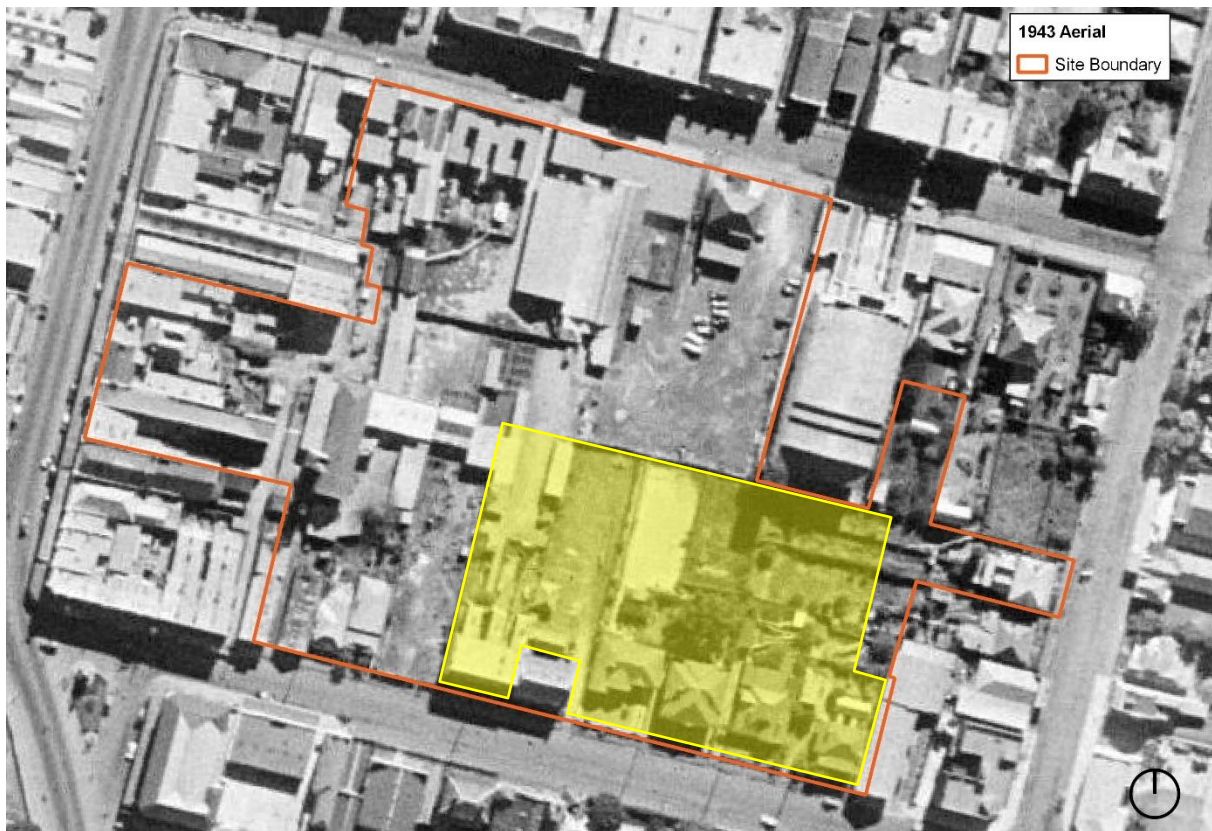
Figure 2.4 1943 aerial photograph showing large houses and boarding houses on Macquarie Street within the enabling works site, large yards and buildings on parts of George Street and multiple subdivisions on Church Street. (Source: SIX Maps with GML overlay)

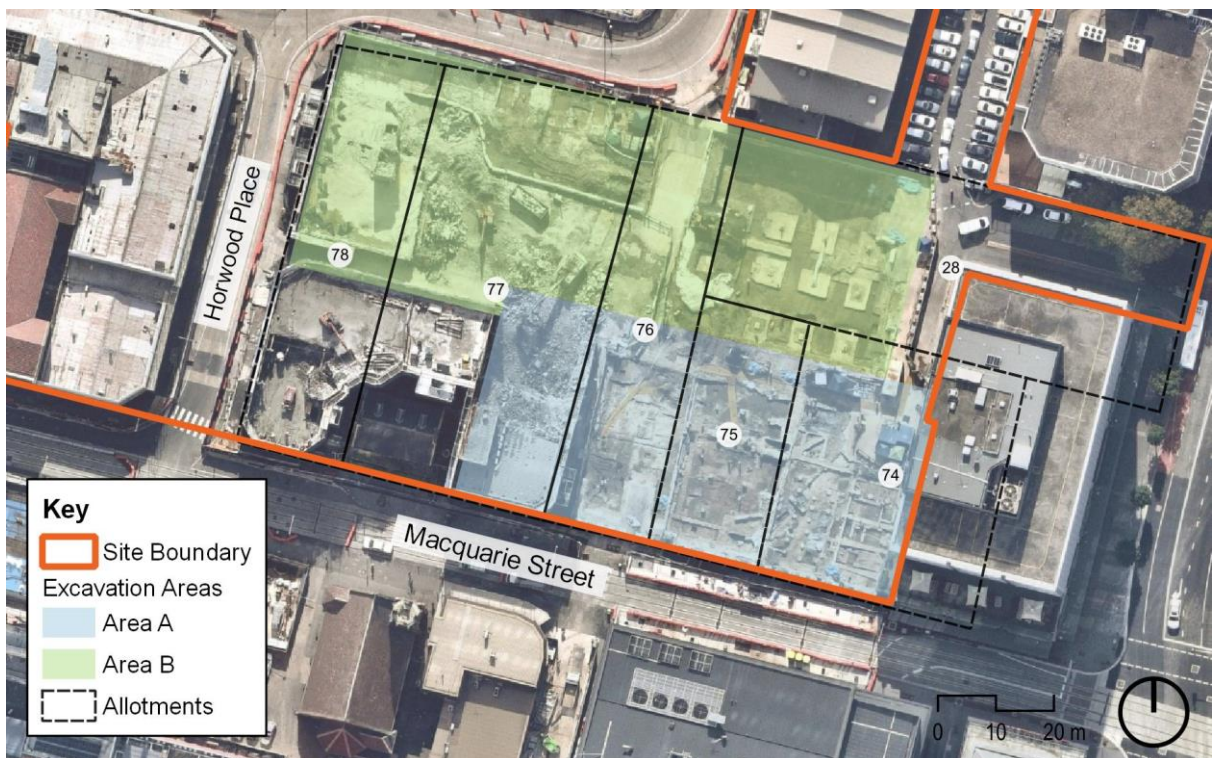
Figure 3.1 The site was divided into two excavation Areas (Areas A and B). (Source: Nearmap with GML overlay)

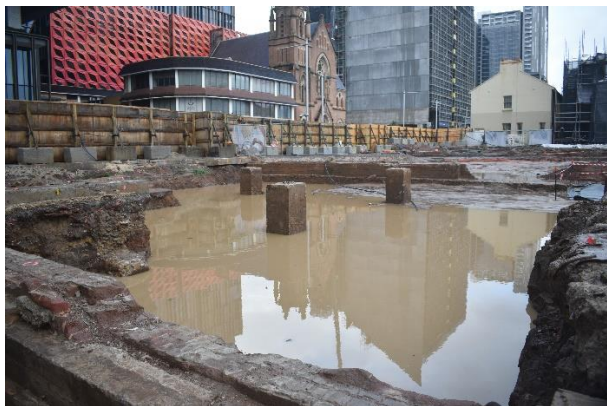
Figure 3.2 Area A, Lot 75, under water following heavy rains in July 2022. Photograph taken looking southwest, towards Macquarie Street.

Sydney recorded its wettest year on record in 2022.<sup>1</sup> Frequent heavy rains from March to July impacted the archaeology program. The lower-lying eastern part of the site (Lots 74, 75 and part of Lot 28) was frequently inundated with water that was slow to drain. A particularly heavy period of rainfall towards the end of the excavation in early July 2022 resulted in the entire site being flooded and inaccessible for over a week. Severe rain events and wet conditions resulted in delays and required adjustments to approaches to excavation and recording.

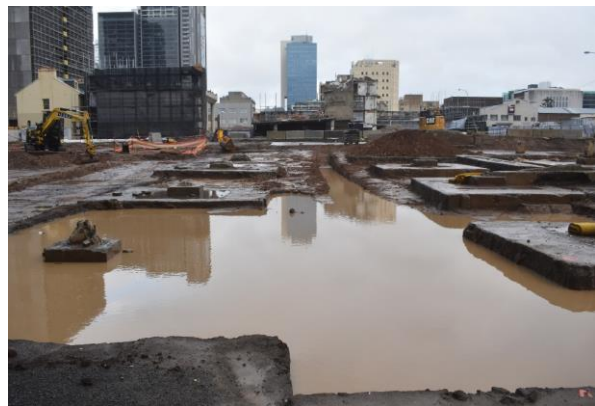
Figure 3.3 Area B and the rear yards of Lots 74 to 76 under water after heavy rain. Photograph taken looking west across the station box excavation area.

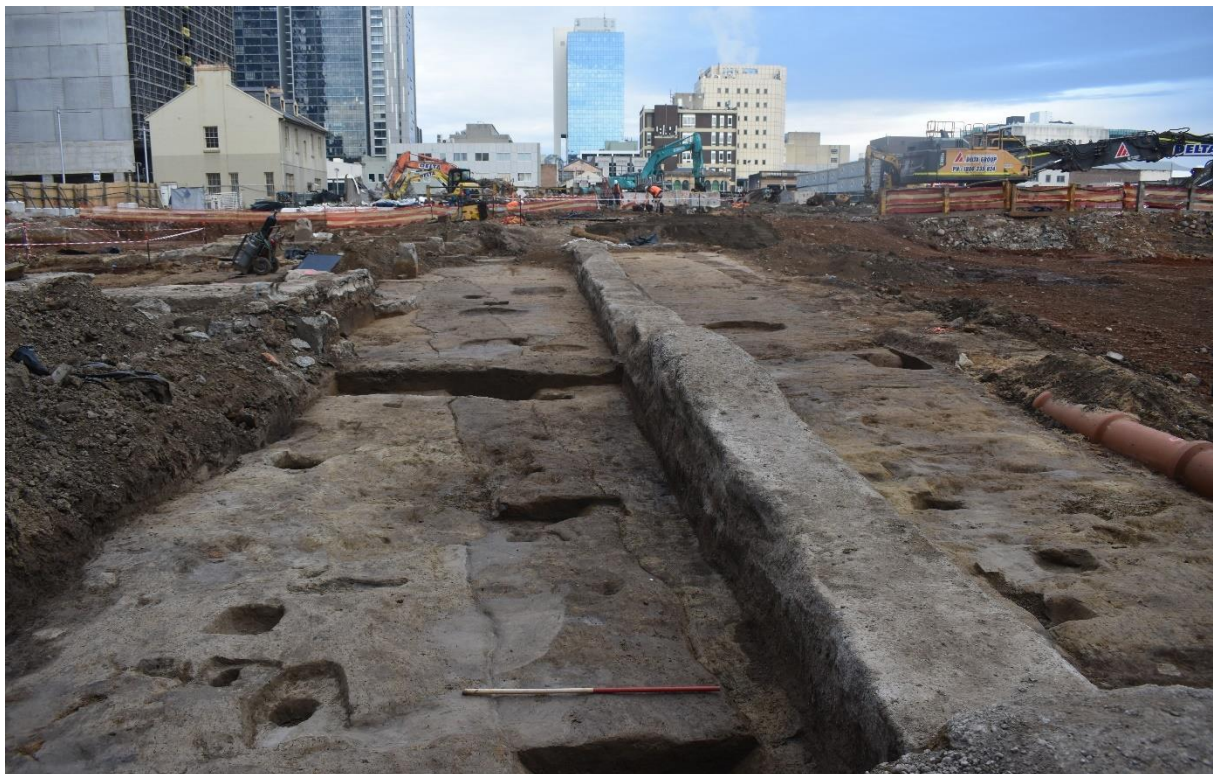
Figure 4.2 A long linear drainage ditch through Lots 76, 75 and 74 dates to the 1790s–1800s and is associated with early cultivation activity prior to development from the 1810s. Photograph is taken looking west. Scale is 1m.

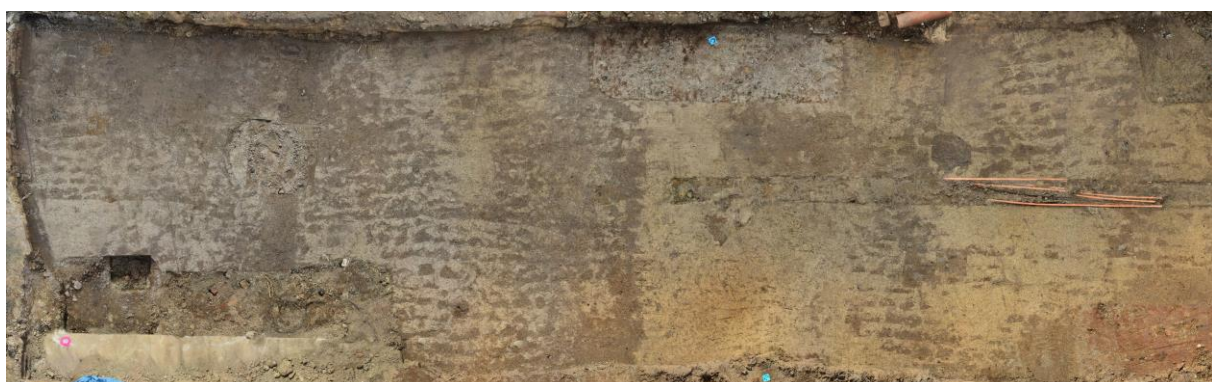
Figure 4.4 Orthophotograph of hoe marks in the subsoil in Lot 78. (Source: Guy Hazell for GML)

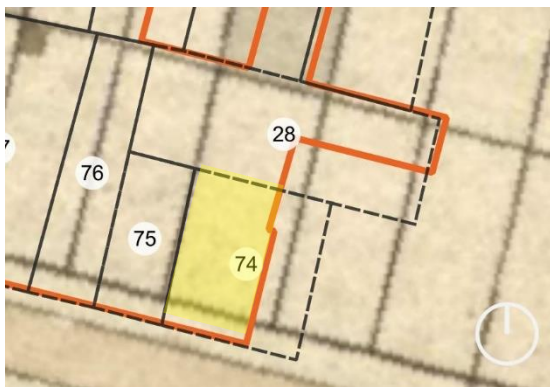
Figure 4.5 Detail from Evans's 1804 survey showing Lot 74 as undeveloped. (Source: The National Archives UK with GML overlay)

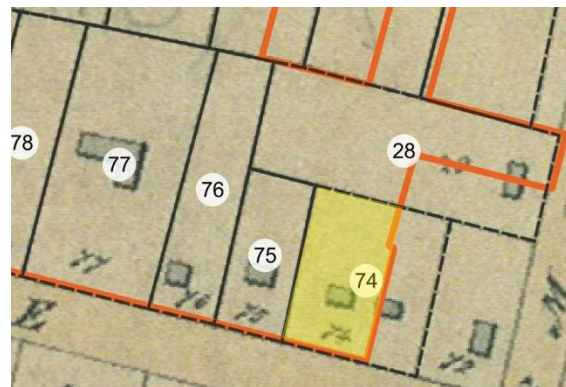
Figure 4.6 Detail from Stewart's 1823 plan showing a structure within Lot 74. (Source: State Library of NSW with GML overlay)

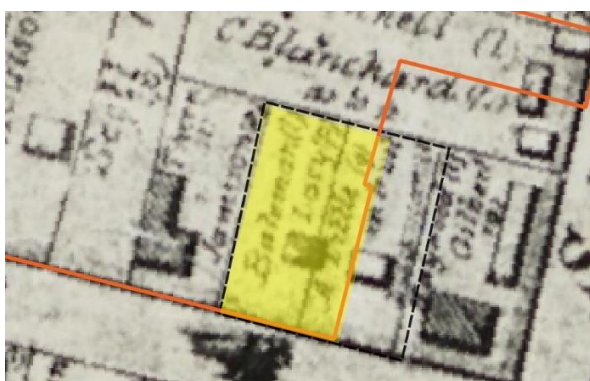
Figure 4.7 Detail from Brownrigg's 1844 survey showing a masonry building (as it is shaded) in Lot 74. (Source: SLNSW with GML overlay)

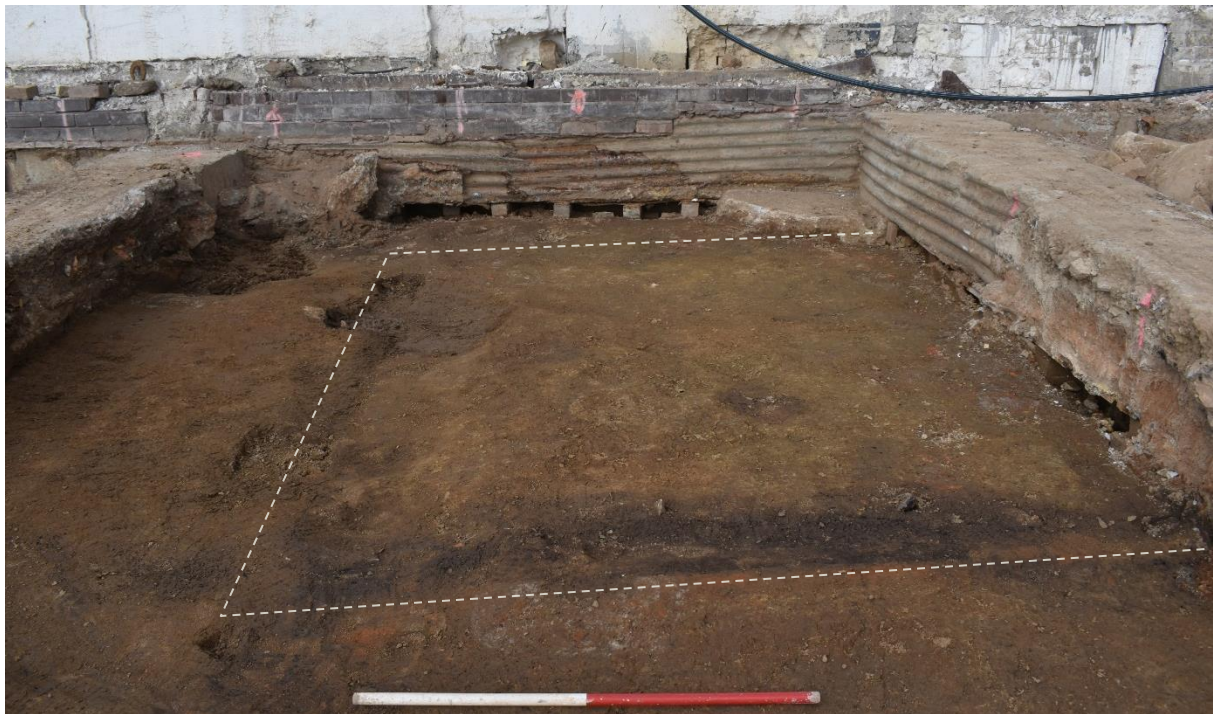
Figure 4.10 Remains of an early nineteenth-century outbuilding behind the cottage in Lot 74. The dark staining in the foreground is the remains of a western wall timber baseplate. The white dashed lines mark the building footprint. Photograph is taken looking east. Scale is 1m.

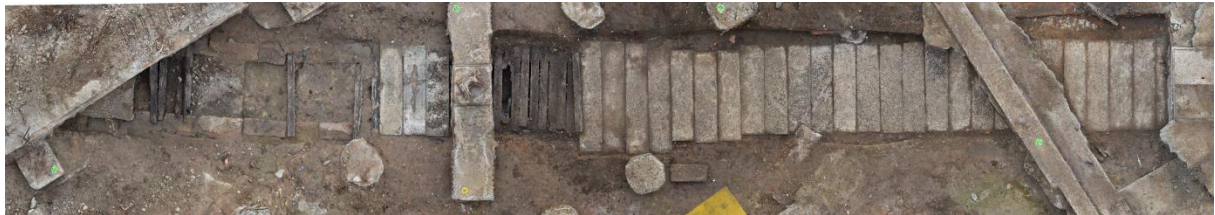
Figure 4.11 Orthophotograph of the Town Drain showing the timber and concrete capping. Several concrete beams were erected to support the 1950s office buildings. (Source: Guy Hazell for GML)

The Parramatta Town Drain (also referred to as the Parramatta Convict Drain) cuts diagonally through Lot 74 from southwest to northeast. This section of the drain was built in the early 1840s. It consists of a sandstone box drain with pre-cast concrete covers installed in the early twentieth century. Several degraded timber boards were also present as capping on the sandstone drain. It is unclear if the timbers are original or a later addition associated with the concrete cover modifications.

Four test trenches were excavated against the drain structure to provide information about its construction and to determine whether it was built into a pre-existing creek or drainage channel. The construction cut was identified in the trenches. A cut was identified in one trench that may be evidence for an earlier channel. Several construction-related backfills and levelling fills were noted abutting the drain structure. A second construction cut was identified for the concrete covers. The internal space contained some fills and sediments; however, these were not excavated.

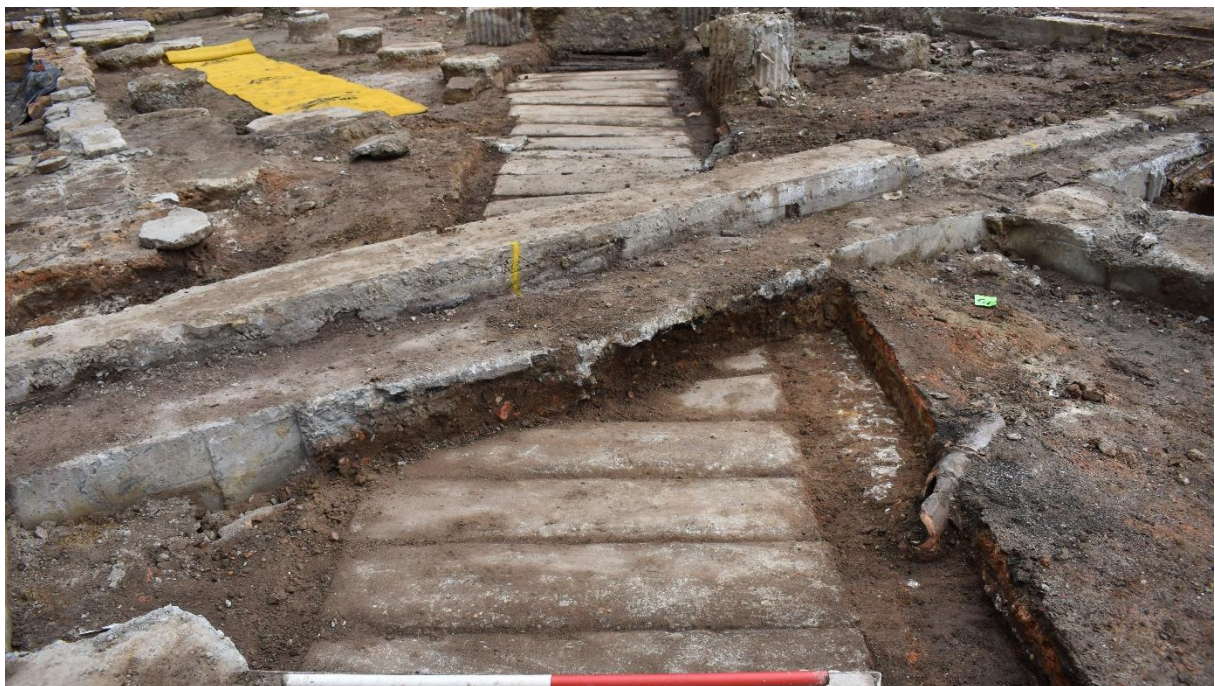
Figure 4.12 The portion of the Town Drain recovered during archaeological investigations of Lot 74. It shows the early twentieth-century concrete covers and substantial mid-twentieth century concrete beams over the drain. The photograph is taken looking southwest towards Macquarie Street. Scale is 1m.

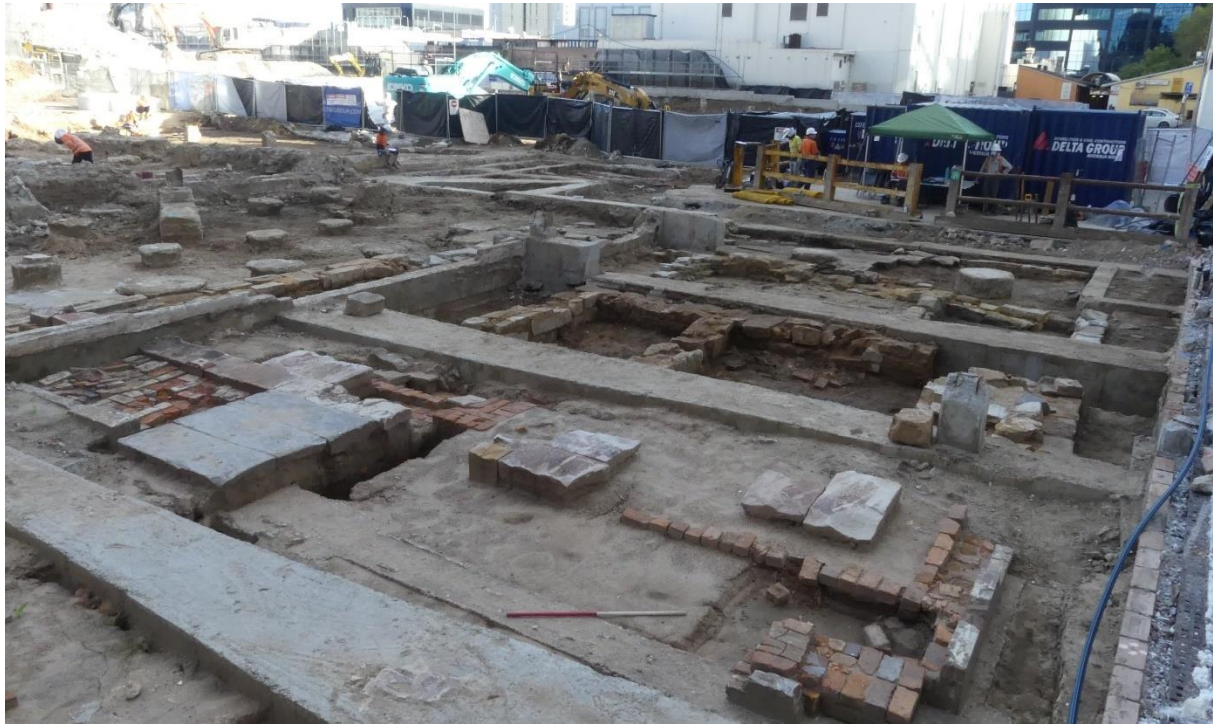
Figure 4.13 The sandstone footings of the substantial two-storey brick house built by the 1850s in Lot 74. The front verandah comprised brick footings and sandstone paving. The archaeology was impacted by concrete footings, piles and beams of the two-storey office building developed on the lot in the 1970s. Photograph taken looking northwest. Scale is 1m.

The site was redeveloped in the mid-nineteenth century and the timber cottage was replaced with a substantial two-storey sandstone and brick building set back from the street frontage. The building was constructed in two main phases, with multiple verandah upgrades and additions in the late nineteenth and early twentieth centuries. In the late

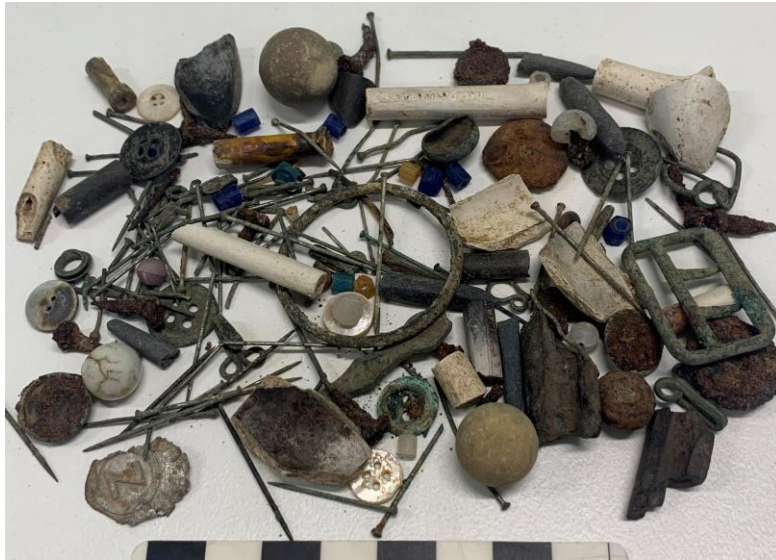
Figure 4.15 Example of small artefacts from within the Lot 74 house including pins, eyelets, buttons, buckles, beads, smoking-pipe fragments and marbles dating to around the mid-nineteenth century. Scale in 1cm increments.

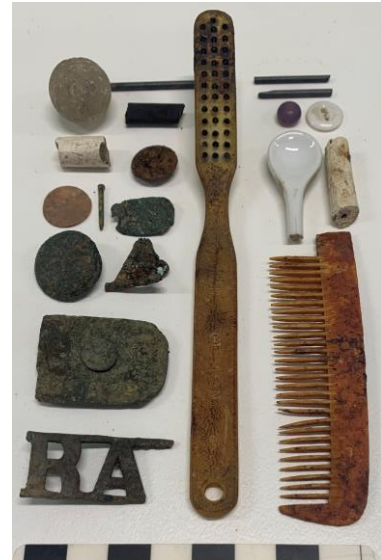
Figure 4.16 Selection of artefacts from a rubbish dump in the backyard of Lot 74 including personal items such as the comb and toothbrush.

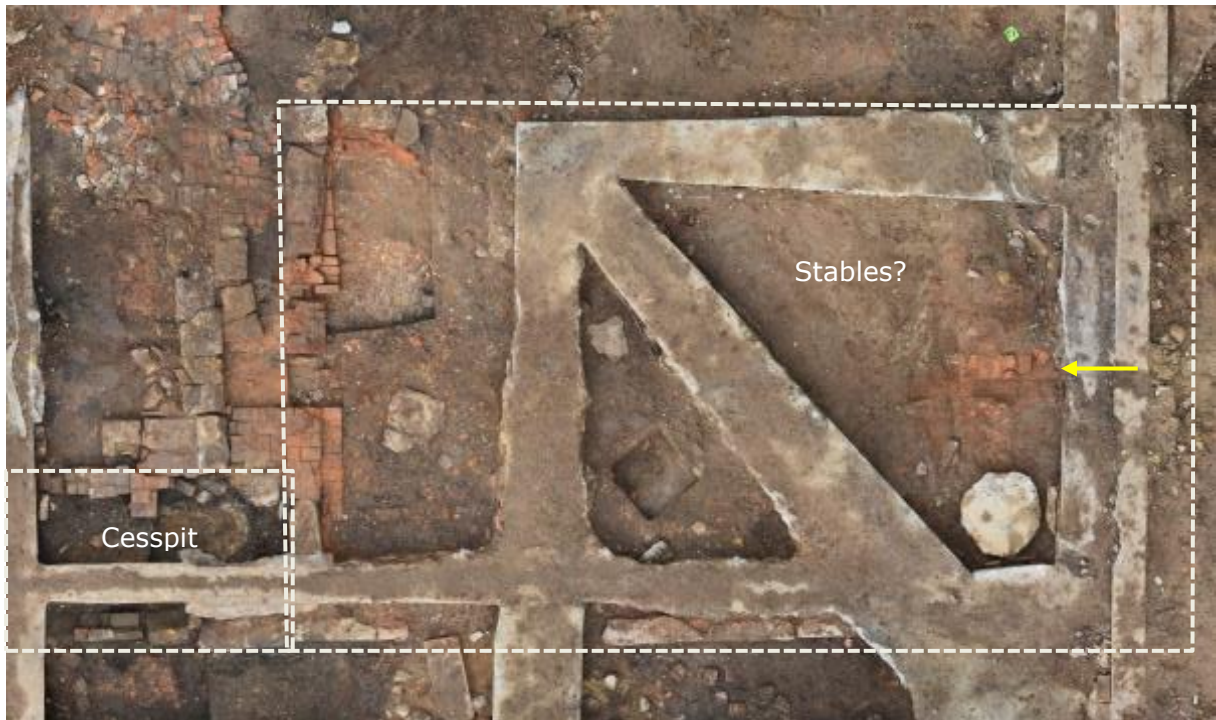
Figure 4.17 Orthophotograph showing the remains of the brick building (likely stables) and cesspit on the western side of Lot 74. The building is outlined with a white dashed line and the yellow arrow notes the remains of the internal partition wall. Most of the building and cesspit had been impacted by twentieth-century development. The image is orientated with east at the top and north to the left. (Source: Guy Hazell for GML)

A substantial outbuilding was located to the rear of the main house. It was a rectangular single-storey two-room building constructed with sandstone footings, brick and sandstone internal paving. It was likely built in the late nineteenth century and may have been a washroom and laundry. Remains of a stables or shed was located on the western lot boundary. The building had sandstock brick footings with an internal partition wall and evidence of later repairs using sandstone. A cesspit backfilled in the late nineteenth century adjoined the stables on the northern side. All outbuildings had been substantially impacted by the later twentieth-century redevelopments.

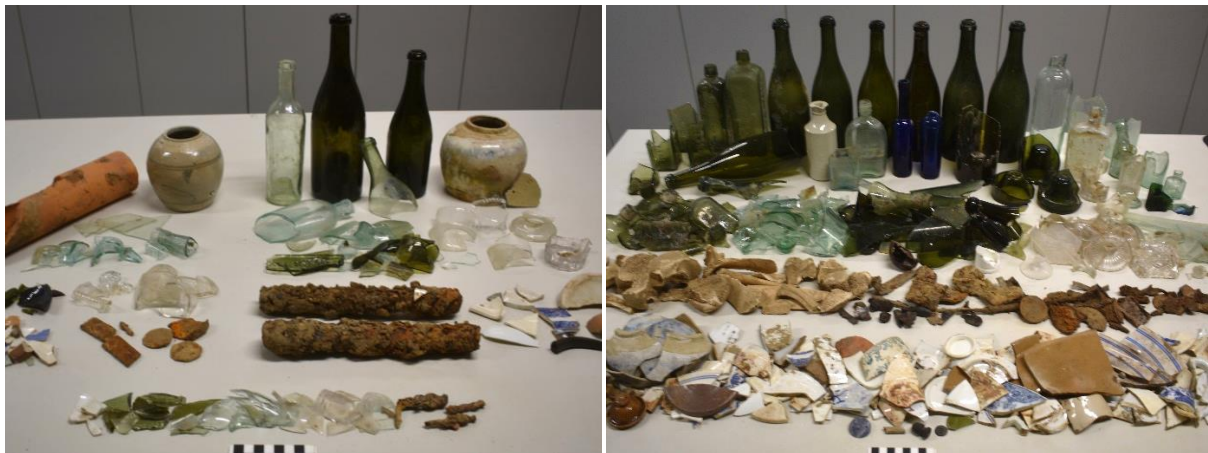
Figure 4.18 Selection of artefacts from the Lot 74 cesspit. Preliminary review provides a late nineteenth-century date for the backfilling. Scale in 1cm increments.

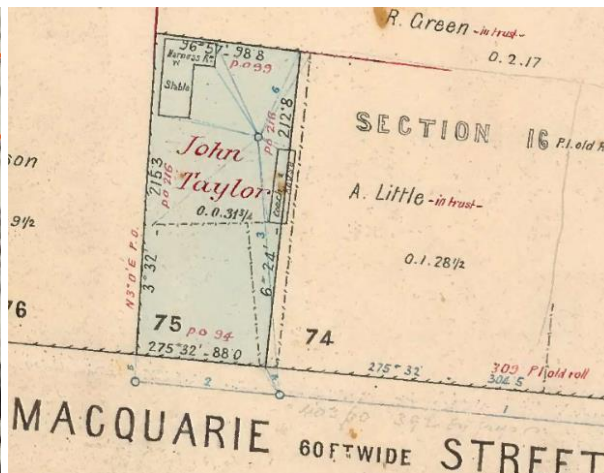
Figure 4.20 The 1894 survey of Lot 75 showing the lot following demolition of the main house with the stables (top left) and coach house (right). (Source: NSW Land Registry Services, Crown Plan 191-750)

Remains of the coach house and stables shown on the 1894 survey (Figure 4.20) were uncovered during the excavation. Although not shown on earlier plans, these structures are thought to have been constructed around the same time as the L-shaped building.

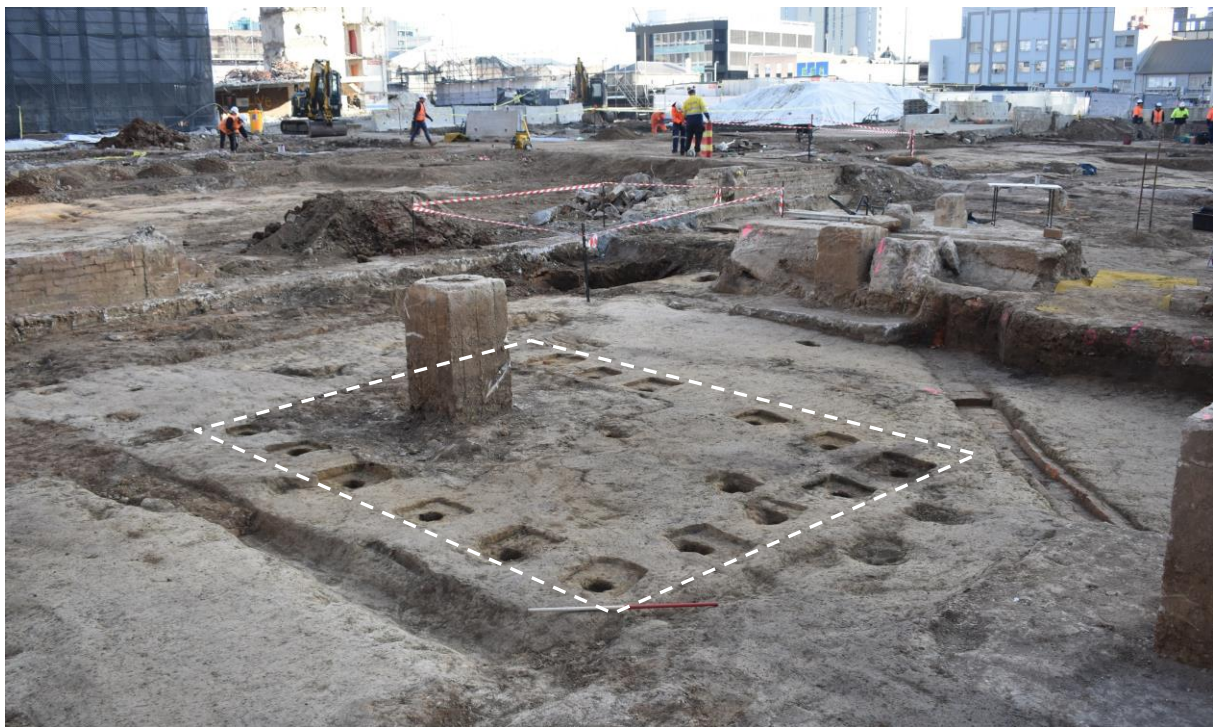
Figure 4.21 The remains of the small timber-framed cottage in Lot 75 and on Macquarie Street in the 1820s. The archaeology was impacted in the twentieth century by concrete pad footings. Photograph taken looking northwest. Scale is 1m.

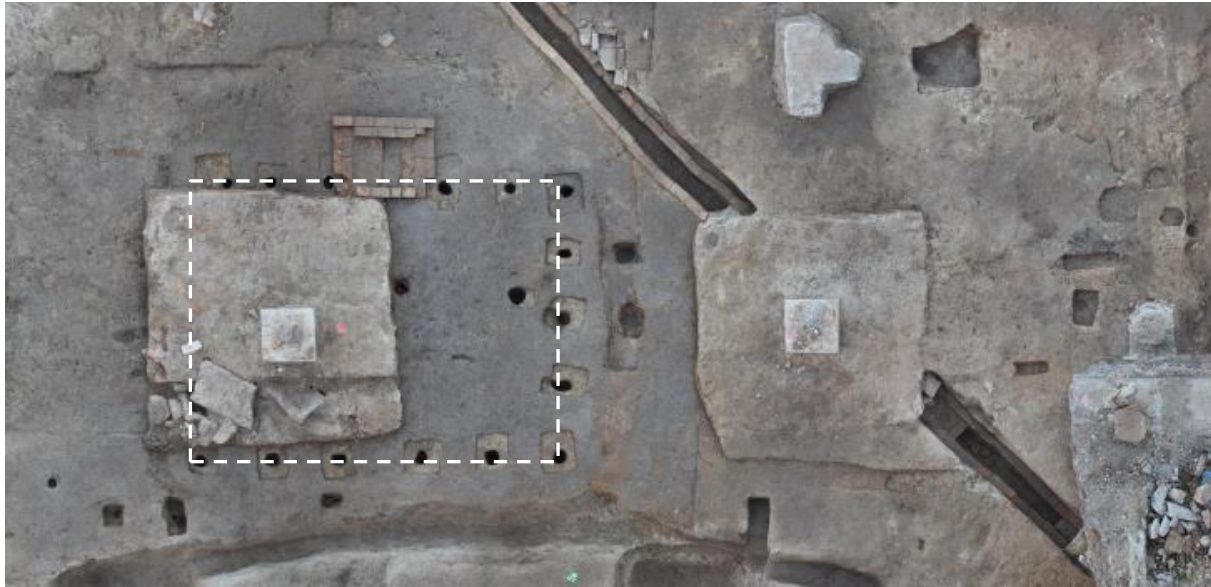
Figure 4.22 Orthophotograph showing the postholes, brick chimney and fireplace, and brick box drain associated with the c1810s–1830s occupation in Lot 75. (Source: Guy Hazell for GML)

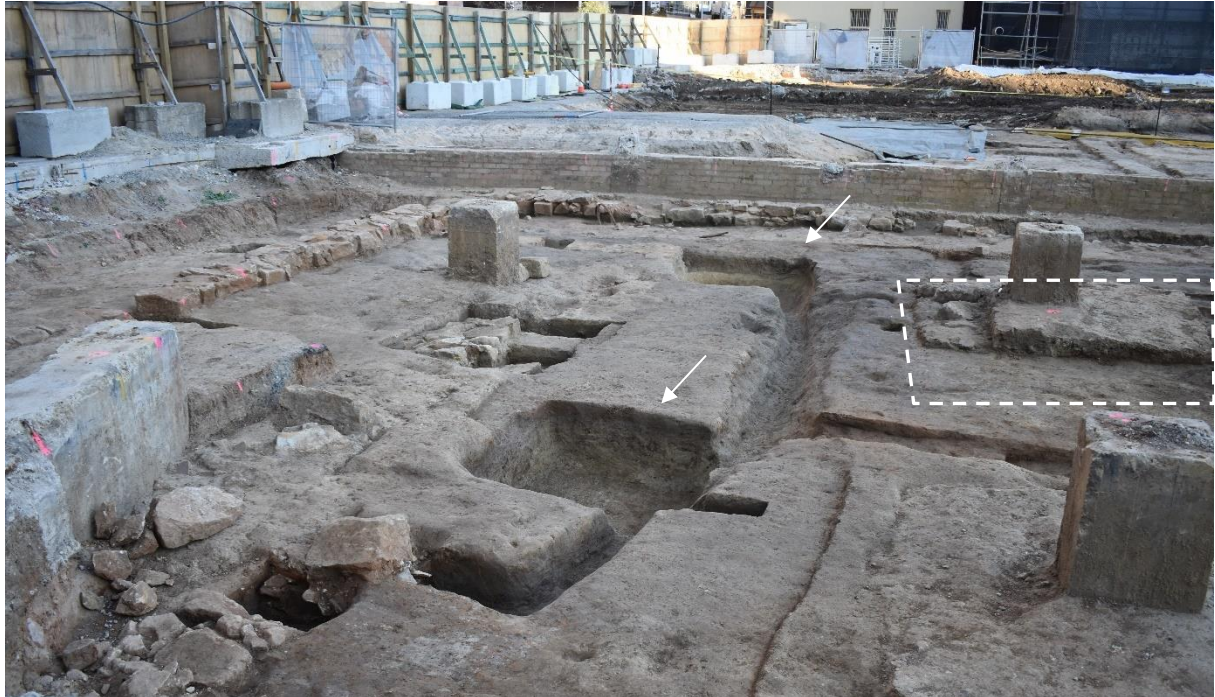
Figure 4.23 Two large square pits (white arrows) connected by channels between the cottage (dashed white line) and Macquarie Street (behind the hoarding) may be related to water storage or management in Lot 75 during the c1810s–1830s. Photograph is taken looking west.

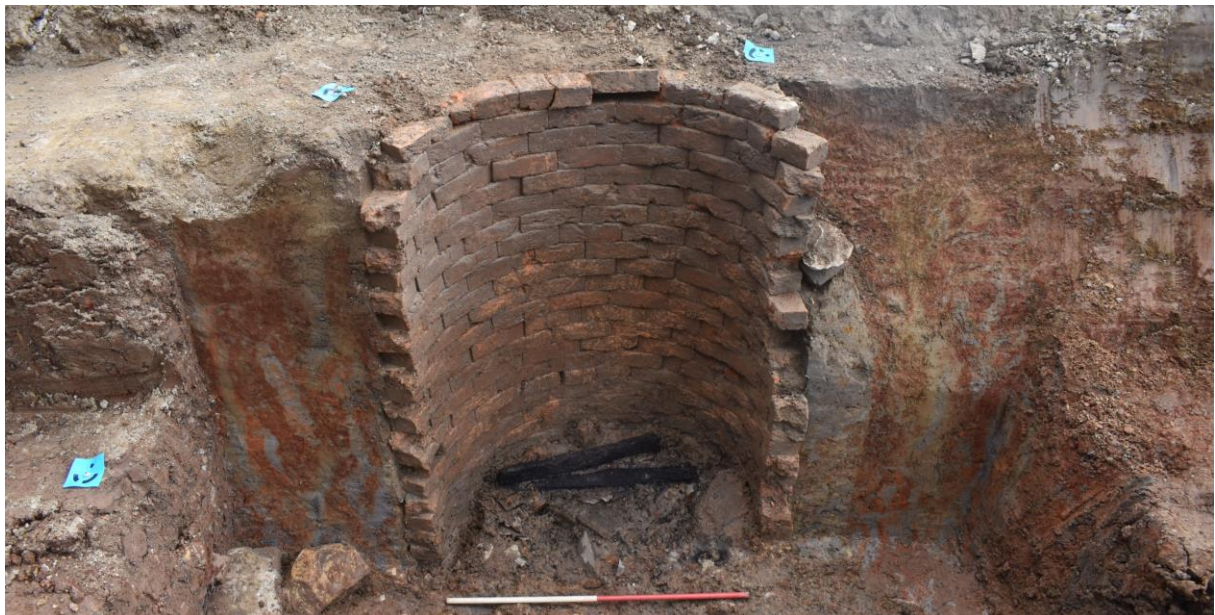
Figure 4.24 Remains of the brick-lined well along the western boundary of Lot 74. Photograph taken looking west. Scale is 1m.

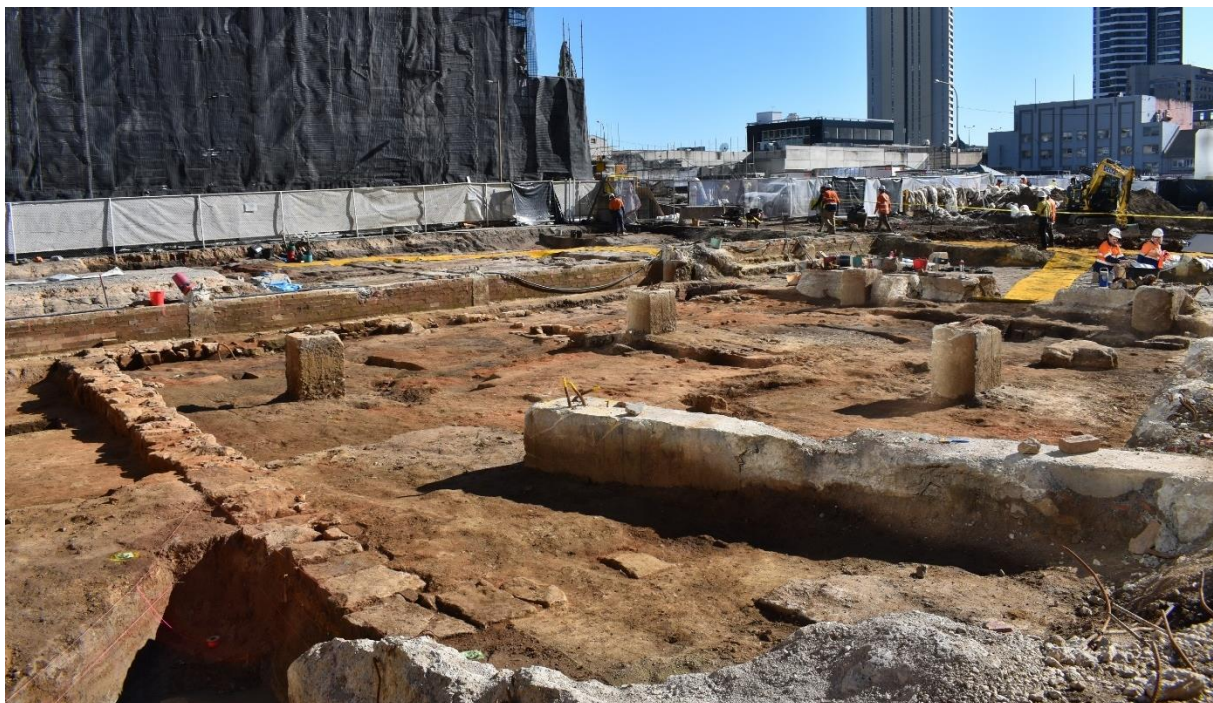
Figure 4.25 The sandstone footings of the L-shaped building constructed in the late 1820s–1830s in Lot 75. Photograph is taken looking northwest across the building footprint. The concrete piles and footings are from the 1970s redevelopment.

The small timber cottage was replaced by the early 1830s. The redevelopment consisted of a building that is shown on an 1831 sketch of Lot 75 and is thought to have been constructed in the late 1820s. This sketch suggests the building was initially a rectangular structure and was later extended to form the L-shape building recorded on the 1844 plan. The archaeological evidence also suggests this; however, further detailed analysis of the findings and historical records is needed. The main building facing Macquarie Street was large, measuring 13m × 8m, and constructed with sandstone footings. The internal wall footings had been removed during the demolition stage, but the robbed-out trenches were visible and provide an internal layout plan for the ground floor.

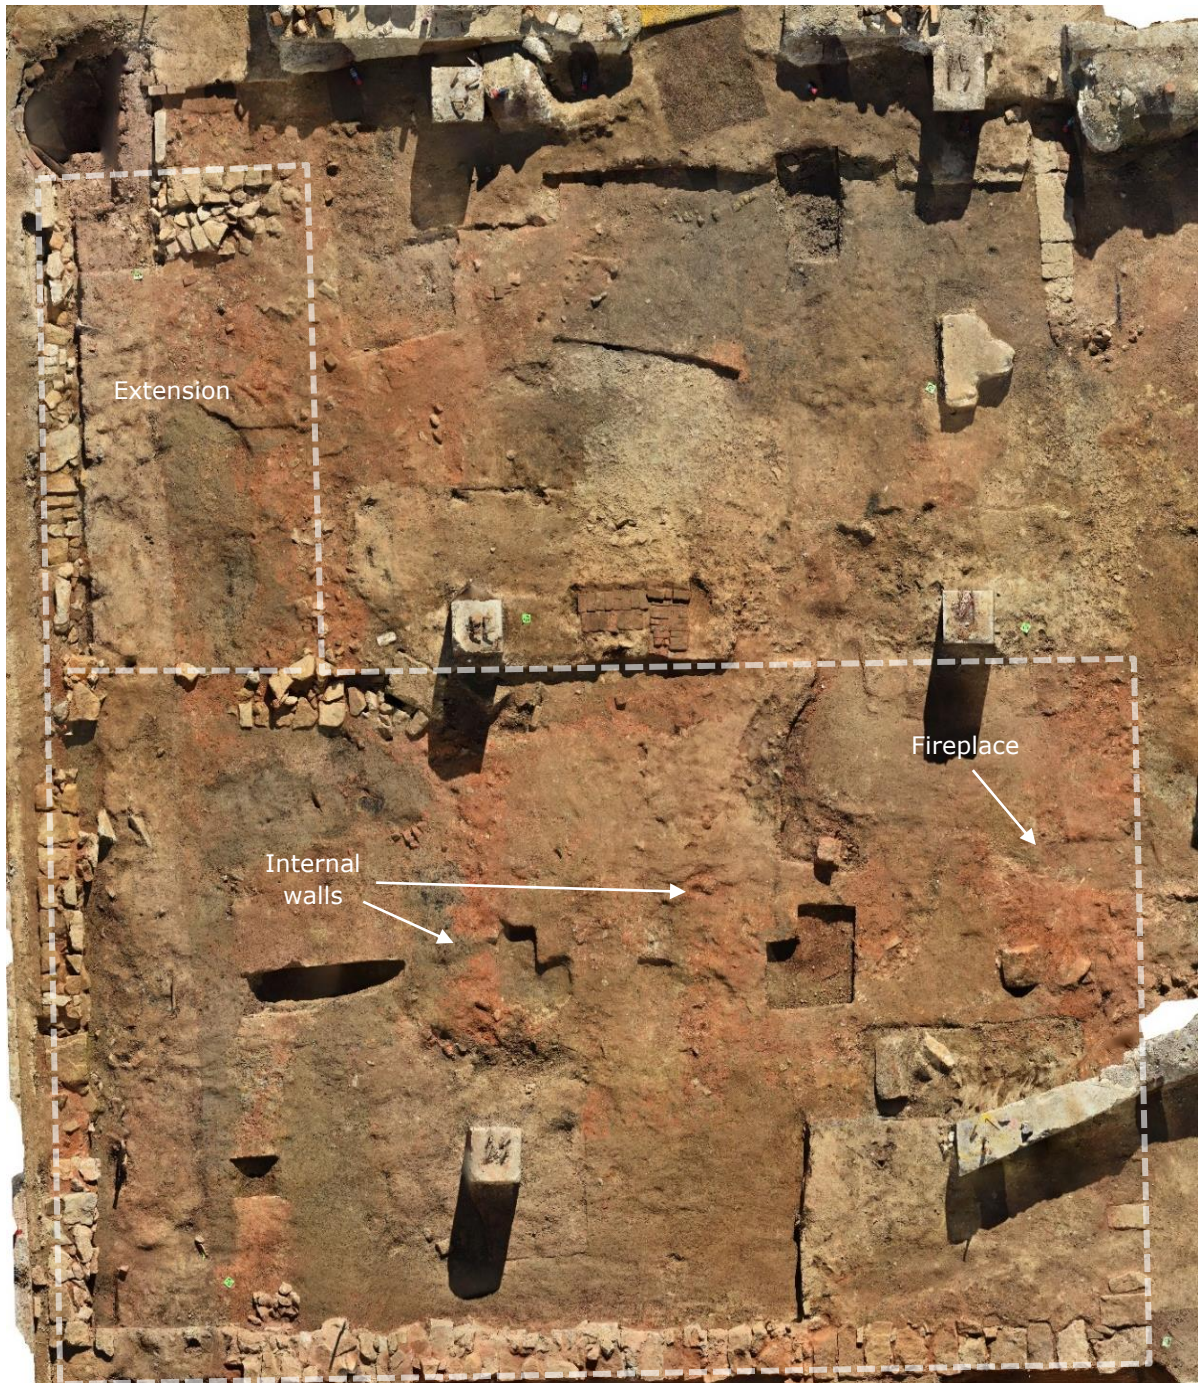
Figure 4.26 Orthophotograph showing the sandstone footings of the L-shaped building in Lot 75. The building was constructed in the late 1820s or early 1830s and it was extended by the mid-1840s. (Source: Guy Hazell for GML)

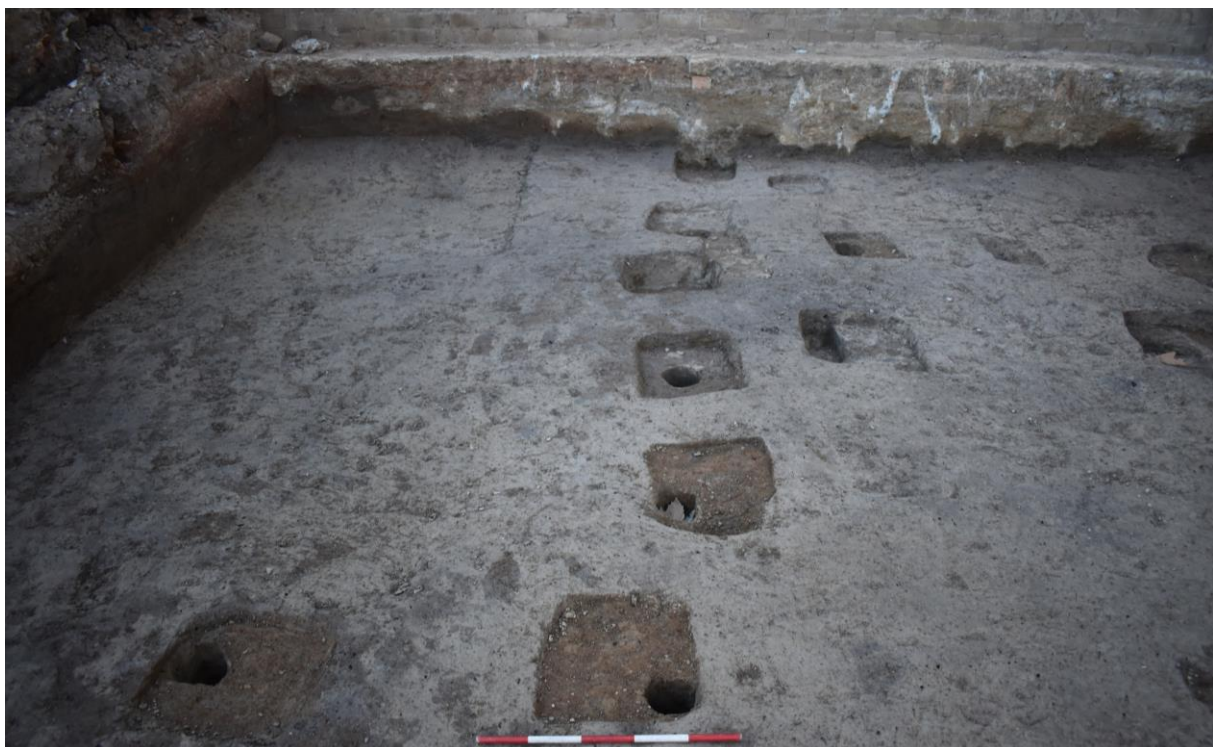
Figure 4.27 Postholes from a timber-framed building that is interpreted as the coach house were identified along the eastern boundary of Lot 75. Photograph is taken looking south. Scale is 500mm.
