# **Sydney Metro West**

## **Parramatta Station Construction Site**

### **Enabling Works**

**Preliminary Results Report**

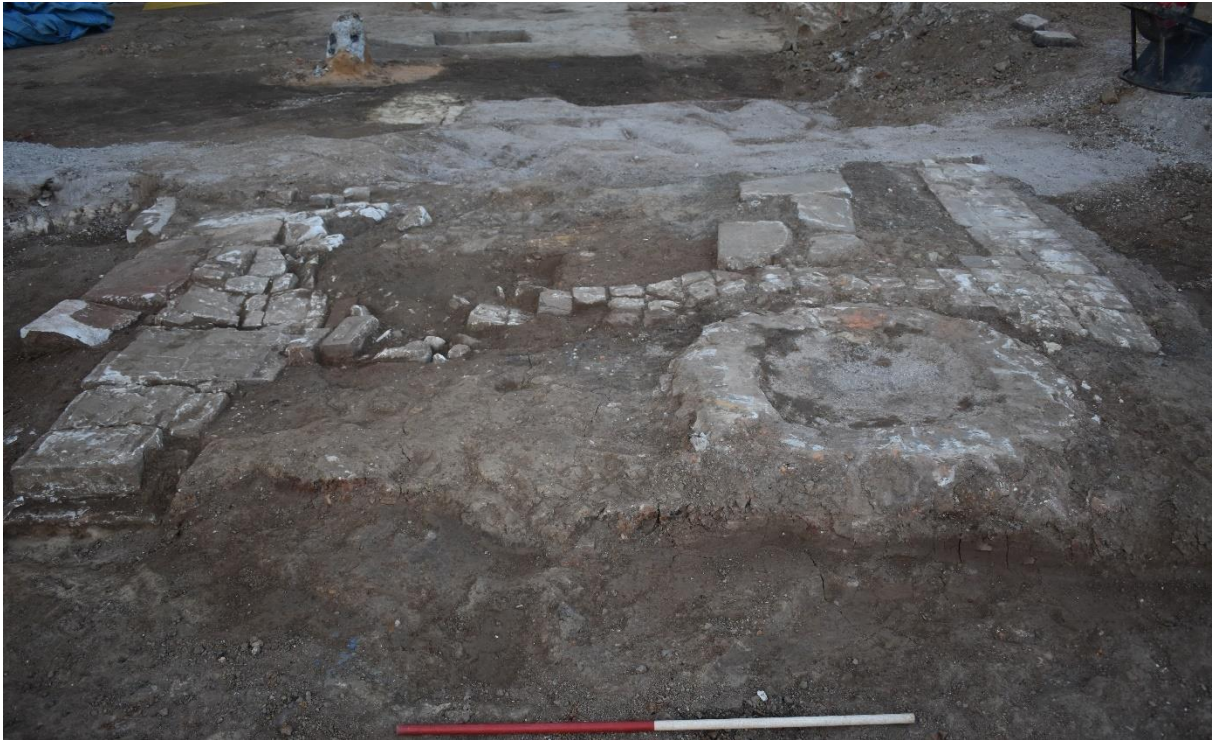
Figure 4.28 Looking south at the remains of the stable, showing the poor level of preservation. The circular feature is a sewer manhole. Scale is 1m.

Only the middle section of the stables was found at the rear of Lot 75, the rest of the building having been removed by a modern sewer trench and the carpark footings. The building was constructed with sandstone footings and machine-made brick walls (Figure 4.28). The bricks suggest the building was constructed in the later nineteenth century, although this may also be a renovation to an earlier structure. A crushed sandstone surface covered the yard space to the east of the building. This structure was poorly preserved, which limited the interpretation of the structure's layout. A row of three postholes below the later masonry structure may indicate the existence of an earlier timber building.

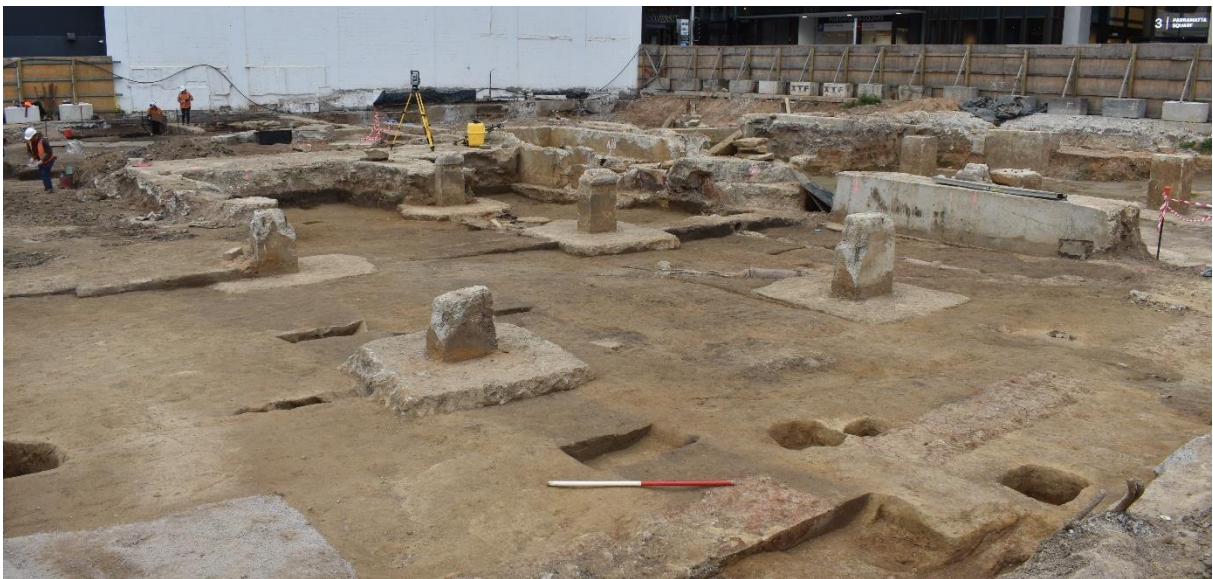
Figure 4.29 Looking southeast across the rear yard in Lot 75 at the end of machine excavation. Scale is 1m.

The northern half of Lot 75 was reasonably intact and preserved a natural soil profile below the modern fills. A fence line indicated by a row of postholes was found close to the boundary with Lot 76. Several other postholes may be part of small timber sheds or garden features. Rubbish pits and dumps were also present.

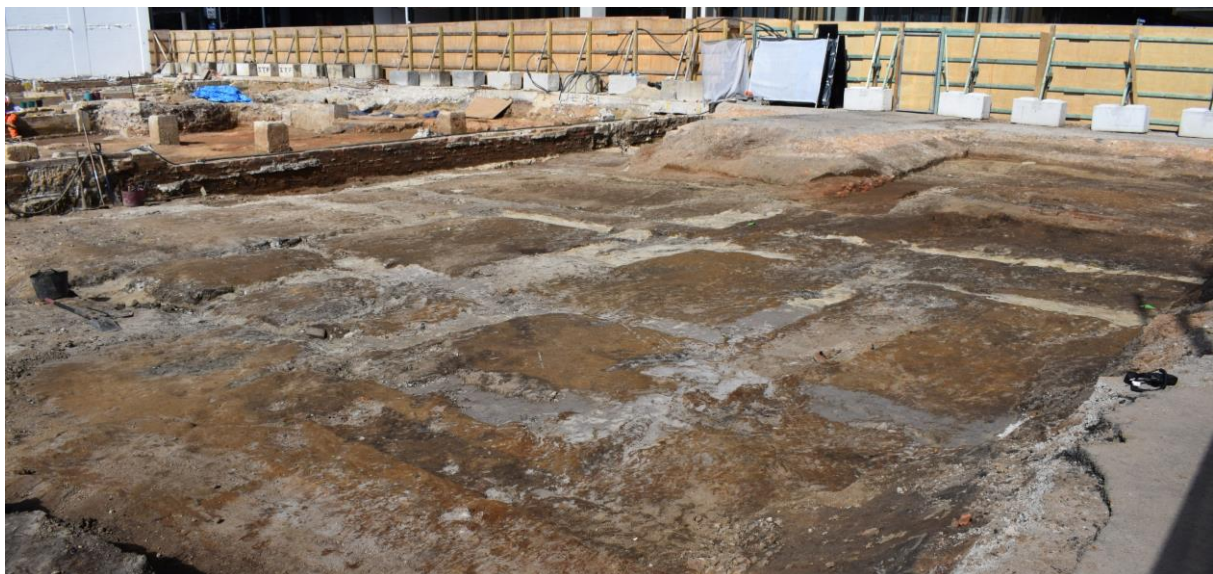
Figure 4.30 The archaeology of Lot 76 had been impacted by twentieth-century development. This view across the lot and towards Macquarie Street shows sand-filled footing trenches from the 1930s apartment building and the land cut down to natural soils.

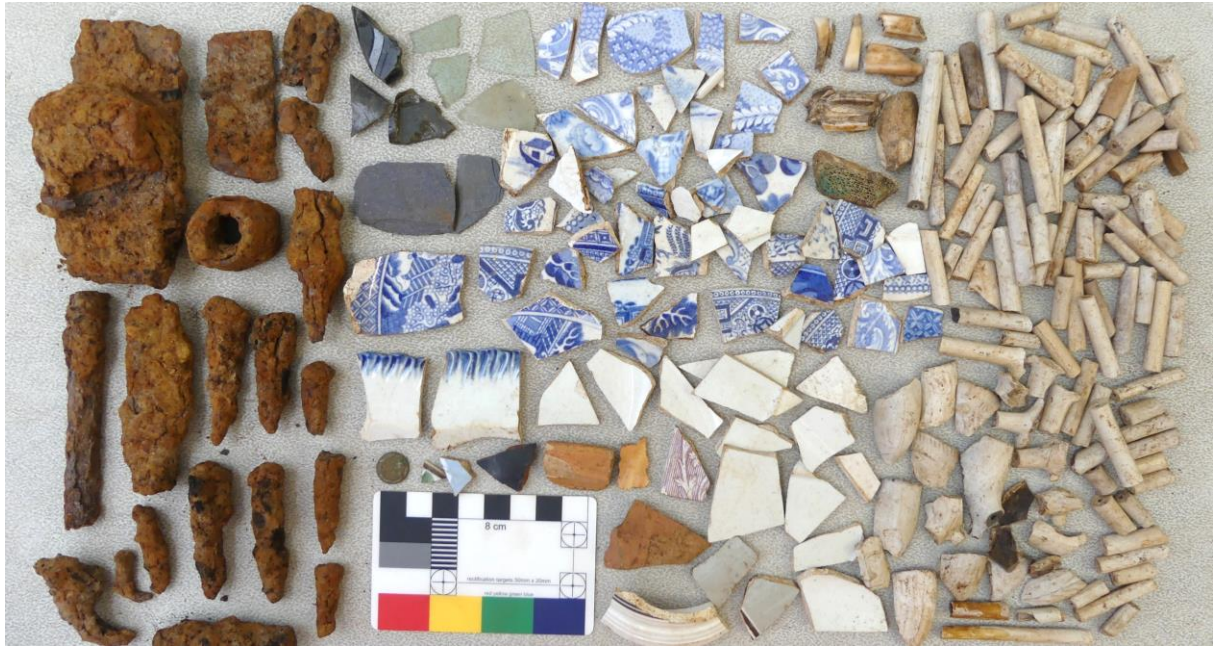
Figure 4.33 Artefacts from the front threshold of the cottage in Lot 76.

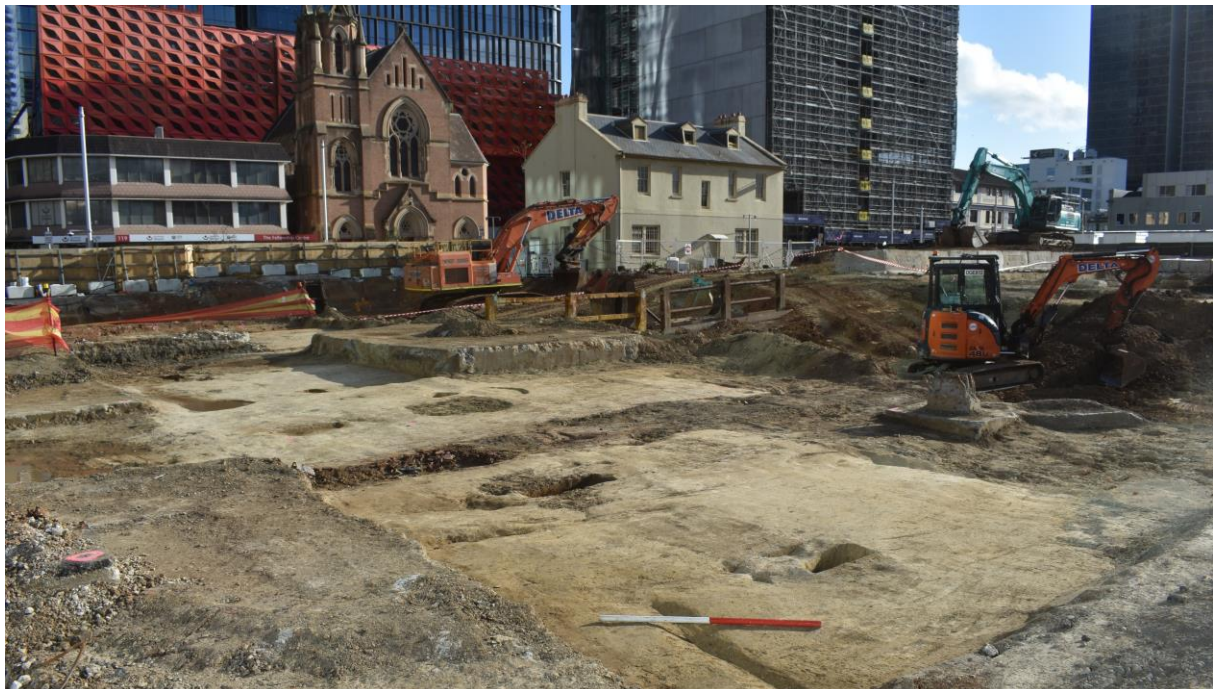
Figure 4.34 Looking southwest across the rear yard of Lot 76. Few features were identified, which is consistent with the documented history of this property. Scale is 1m.

Historical maps and aerial photographs depict the lot as largely undeveloped. Later twentieth-century impacts truncated and impacted the rear yard. As a result, relatively few archaeological features and deposits were present.

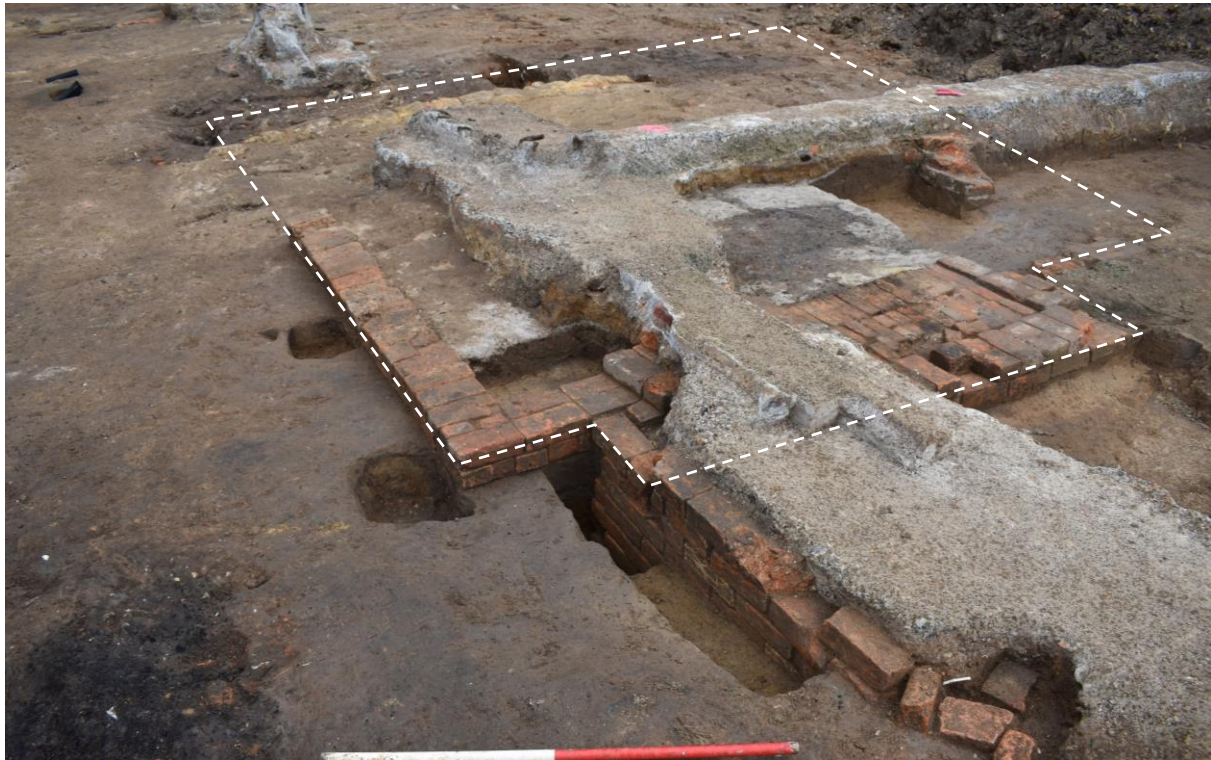
Figure 4.36 Sandstock brick and sandstone footings of a small one-room cottage with a brick hearth in Lot 77. Photograph taken looking south towards Macquarie Street. Scale is 1m.

Remains of two buildings illustrated on the 1895 plan were found within the central portion of the lot, on the eastern side. The first structure comprised sandstone and brick footings with remains of a brick chimney and fireplace on the northern (back) wall. Overlays with the historical plans suggest these remains are part of the small building illustrated on the 1844 and 1895 plan and associated with Houison's development and occupation. However, the construction date is unclear at this stage, and they may be

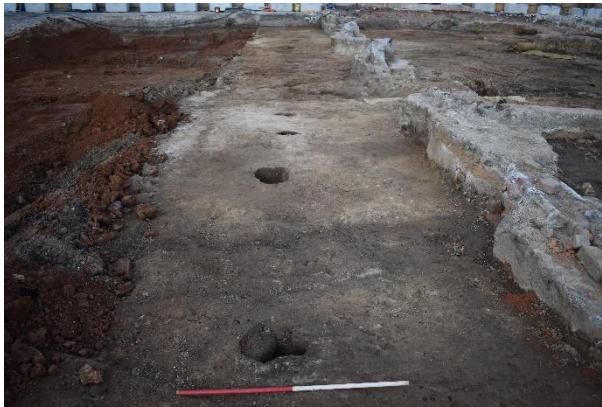
Figure 4.39 Row of posthole from the boundary fence between Lots 77 and 76. Photograph taken looking south towards Macquarie Street.

A large circular cut with sandstone edging was located close to Kia Ora. This feature may be the remains of an ornamental garden bed or possibly a fountain. It was backfilled with material containing a relatively large quantity of butchered animal bone. Lines of postholes provide evidence for the boundary fence with John Thorn’s property to the east (Lot 76). Remains of a sandstock brick dish drain and box drain to the rear of the houses were also present; however, the features were significantly impacted by later twentieth-century development. Remnant historical, modified topsoil was present in localised areas in the rear yard and northern half of the lot. The base of several furrows could be identified. Remains of several rubbish pits containing artefacts were also present.

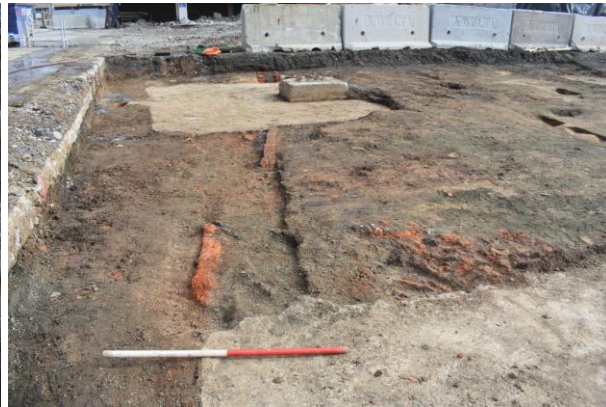
Figure 4.40 Remains of a sandstock brick box drain in the rear yard of Lot 77. Photograph taken looking west. Scale is 1m.

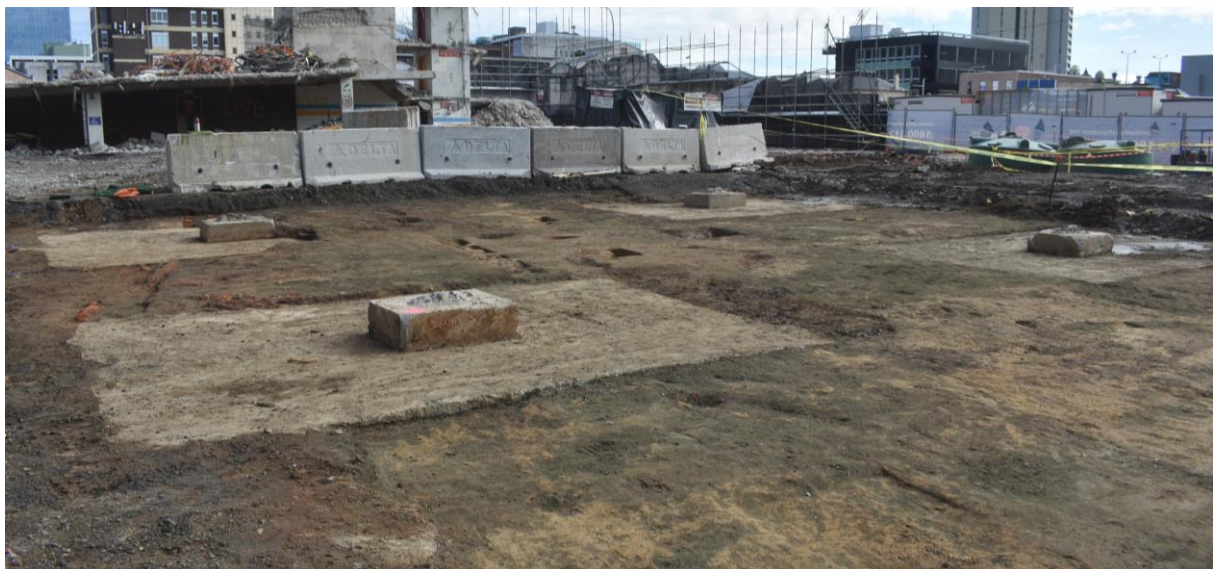
Figure 4.41 The rear yard of Lot 77 had been truncated by twentieth-century development and only localised patches of historical topsoil and the bases of agricultural furrows were present. Photograph taken looking northwest.

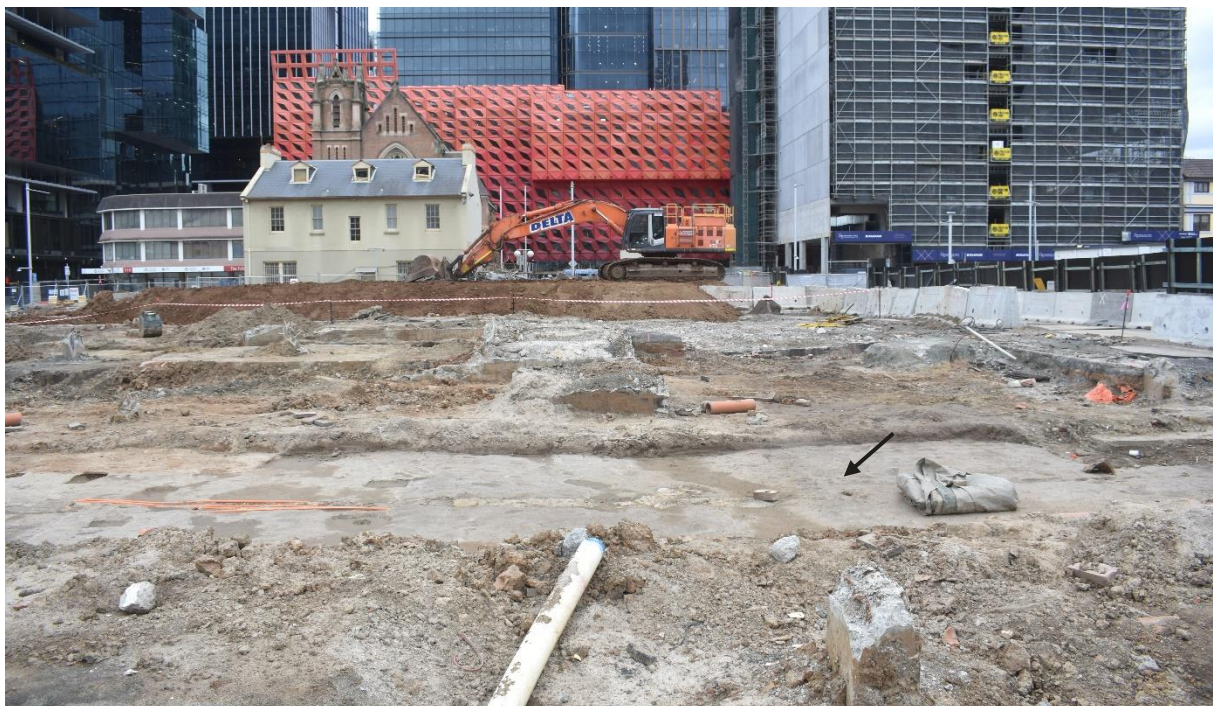
Figure 4.42 Looking south across Lot 78 towards Macquarie Street. The arrow indicates the narrow area of archaeology that survived the later twentieth-century development impacts.

There was no recorded development until after it became part of Ritchie’s ironworks. Several buildings were recorded on the 1895 plan—the northern half of the lot contained a large workshop and the southern half had been subdivided and redeveloped with terraces. However, twentieth-century impacts—a substantial basement, lift pit and stairwell, pad footings and road structure—truncated most of this lot to the basal clay. A narrow strip between pad footings contained patches of archaeological deposit with several postholes and concrete surfacing. The postholes and concrete surface may be the remains of the Ritchie’s ironworks buildings or a later twentieth-century warehouse and yard surface.

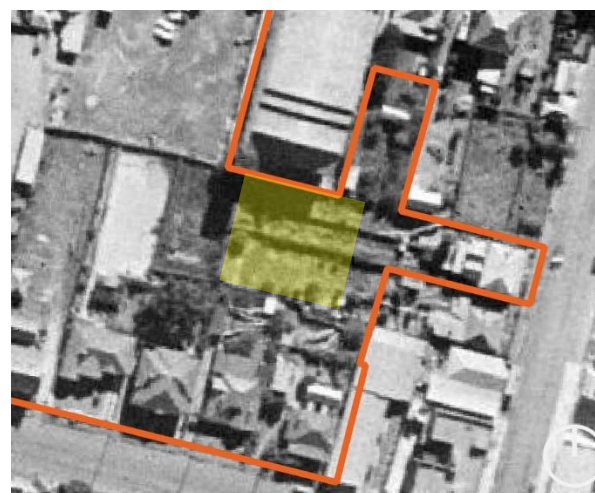
Figure 4.44 Detail from 1943 aerial photograph showing the rear yards of the two Lot 28 subdivisions within the enabling works excavation (yellow shading). (Source: SIX Maps with GML overlay)

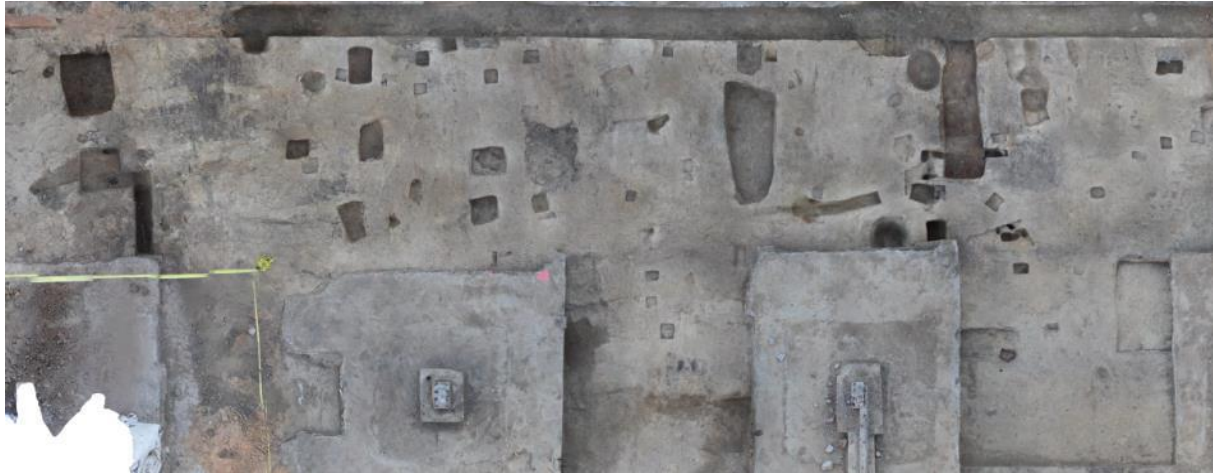
Figure 4.45 Orthophotograph showing the northern subdivision of Lot 28 containing numerous postholes and large rubbish pits. The postholes may be remains of lightweight timber-framed garden structures, such as sheds, chicken coops, and frames for plantings or garden beds.

Multiple phases and arrangements of postholes were found within the garden soil layers, the historical topsoils and cutting the natural subsoil (A<sub>2</sub> horizon). Postholes from several lightweight timber-framed buildings were present. Further analysis is needed to understand the phasing and function of these structures. However, they likely relate to domestic use and could be remains of chicken coops and sheds in the rear garden of the Smith Street properties. Some postholes may also relate to cultivation, garden beds and

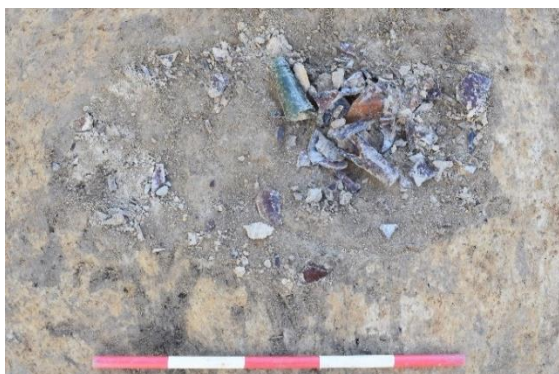
Figure 4.46 Example of a rubbish pit from Lot 28 that contained a large quantity of glass prior to excavation. Scale is 500mm.

Several large rubbish pits and dumps were present in the backyards of both Lot 28 subdivisions. The northern subdivision contained the most intact rubbish dumping related features and the largest quantity of artefacts overall. The rubbish dumping events span the late nineteenth to mid-twentieth century. There were large quantities of metal and glass artefacts, and the preliminary interpretation of the assemblages is that the rubbish dumping relates to commercial activities rather than domestic. Rubbish dumps containing large numbers of early to mid-twentieth century artefacts are not common in Parramatta archaeological sites. The assemblages from the rubbish pits will be a focus for detailed analysis and research.

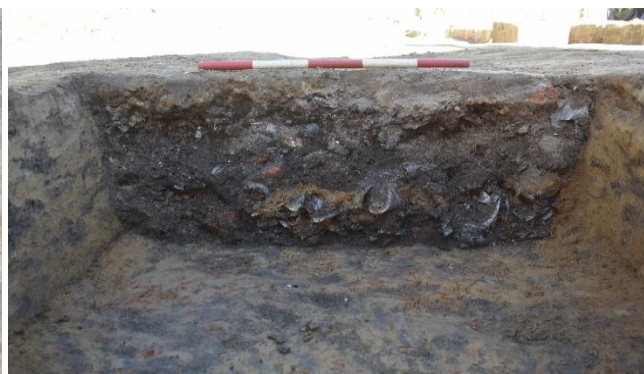
Figure 4.47 Section through a rubbish pit from Lot 28 during excavation. Scale is 500mm.

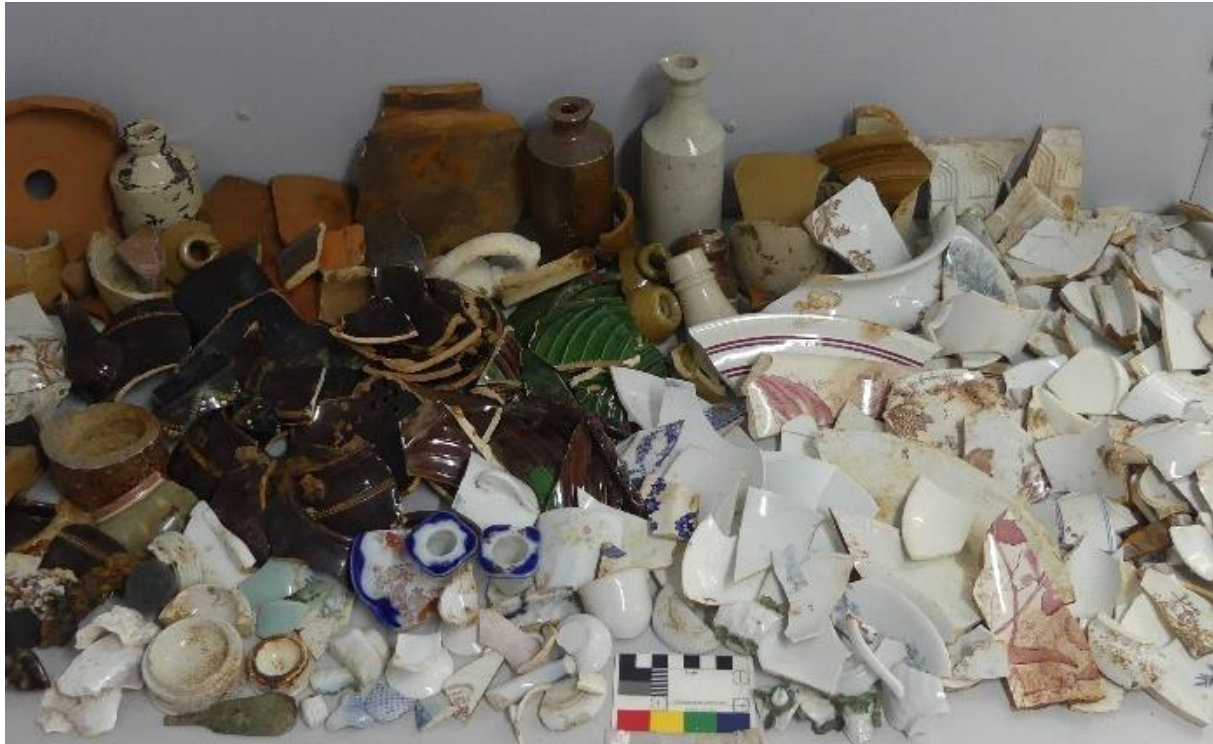
Figure 4.48 Artefacts from a large rubbish pit in the backyard of the Lot 28 northern subdivision.
